# <u>First Field Test</u> ECHO Memorandum #001 November 29th, 2014

Prepared by Mason Denny and Michael Busch

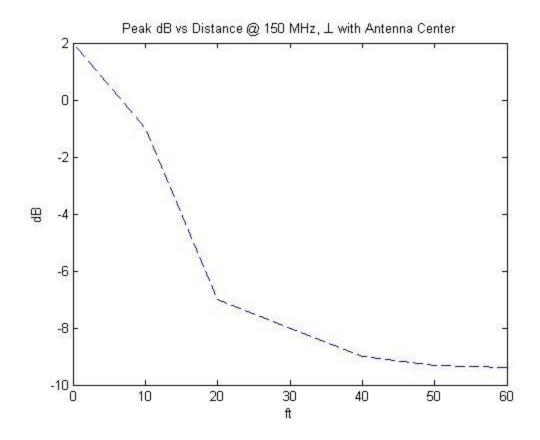
RMS of 150 MHz range test.

Our first test involved standing between the ground antennas and walking perpendicular to them (West) to test the range. Our results indicate that the signal blends into the background noise at around 44 feet.

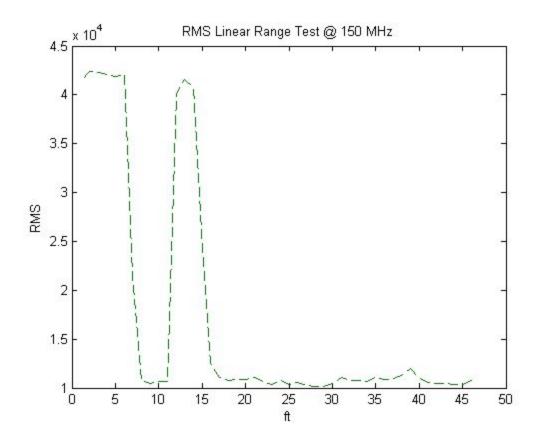
The Linear range test of the RMS, the sudden drop at the beginning of the test may have been due to human test error when Danny ordered Mason to walk forward or backward while still calibrating. We do however, see our receiver hit the noise floor very soon afterwards. We were only able to walk outwards about 20-30 ft before our signal at 150 MHz disappeared.
